## An Altro customer guide

Inspecting floors and walls -  
best practice

# Best practice floors and walls installation: the do's and don'ts

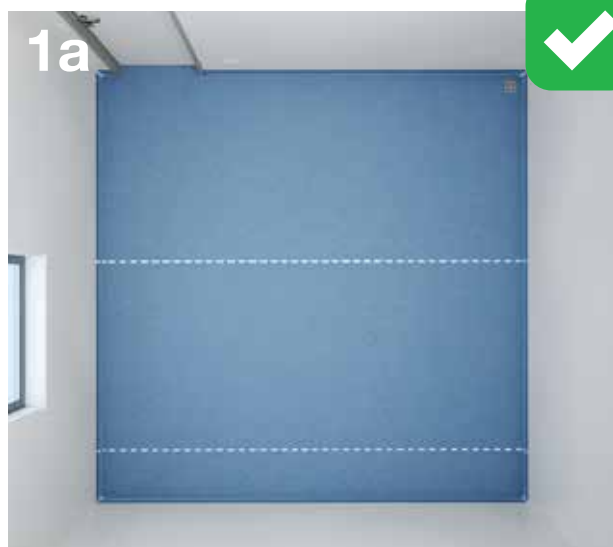
This shows the ideal layout of joints (seen from above).

It is aesthetically pleasing to draw attention away from the joint. It is placed away from the heaviest foot traffic.

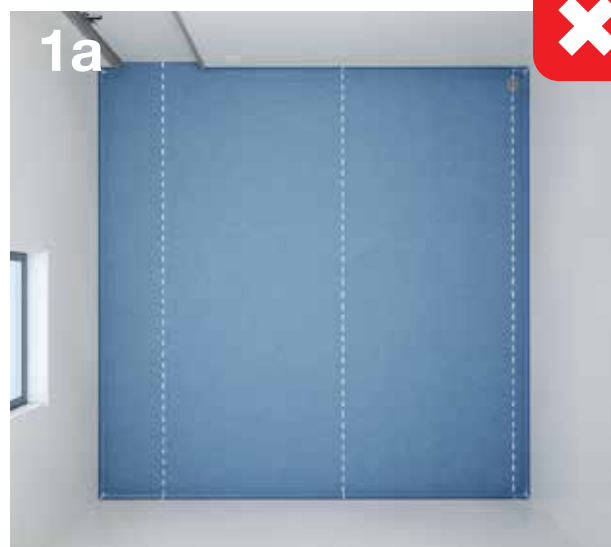
This shows the joint in the middle of the doorway (seen from above).

Your eyes are drawn to the joint in the centre of the room, detracting from the aesthetics of the floor. The joint is exactly where most foot traffic goes, placing unnecessary pressure on the join.

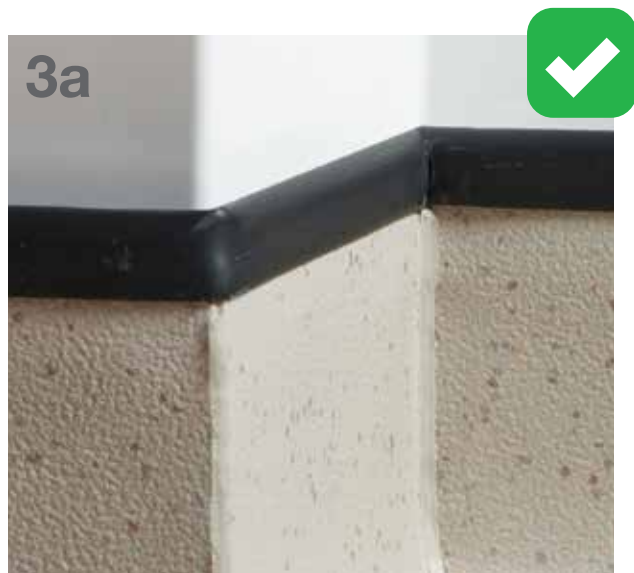
This shows best practice capping for fitting of internal and external corners.

**Internal corner:** by cutting the capping and pushing it into the corner, it creates a better seal, making moisture ingress less likely. It also looks better.

**External corner:** by taking a piece of the capping out and wrapping it around the corner, it creates a continual capping seal, with no gaps. This is less prone to damage and is aesthetically pleasing.

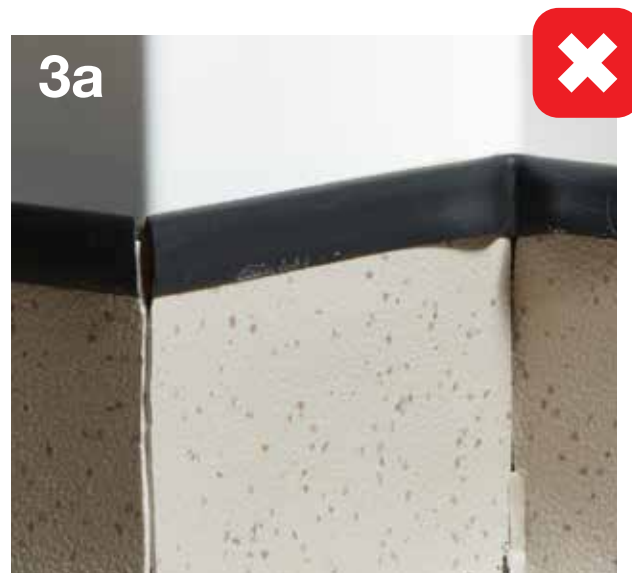
This shows poorly-fitted capping that has been mitred on the internal and external corners.

**Internal corner:** the corners have been mitred, and gaps in the capping can be seen, which will allow moisture ingress. The overall look is poor.

**External corner:** the capping will not be secure and water, bugs and bacteria could get into the gaps. It could also be prone to damage from passing foot and wheeled traffic.

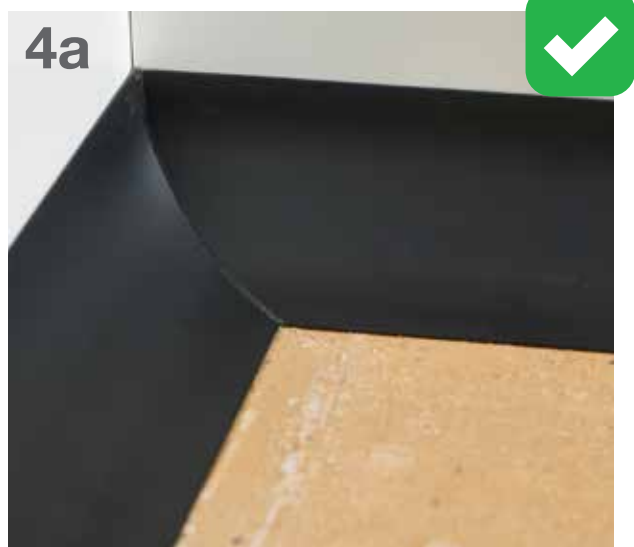
This show a best practice internal corner.

The correctly fitted cove former gives the flooring greater support in the corners. The back section of the right hand piece has been trimmed off so that it firmly overlaps the left piece, leaving no void behind.

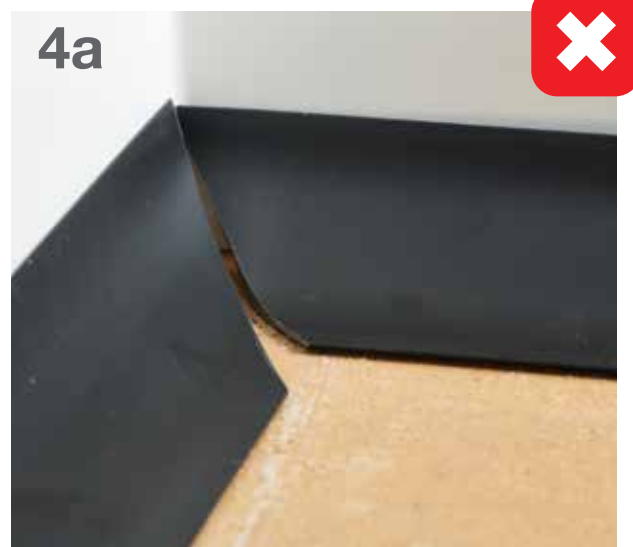
This show a badly cut and poorly fitted internal corner.

Where there is a gap, the cove former offers no support to the flooring, making it susceptible to damage.

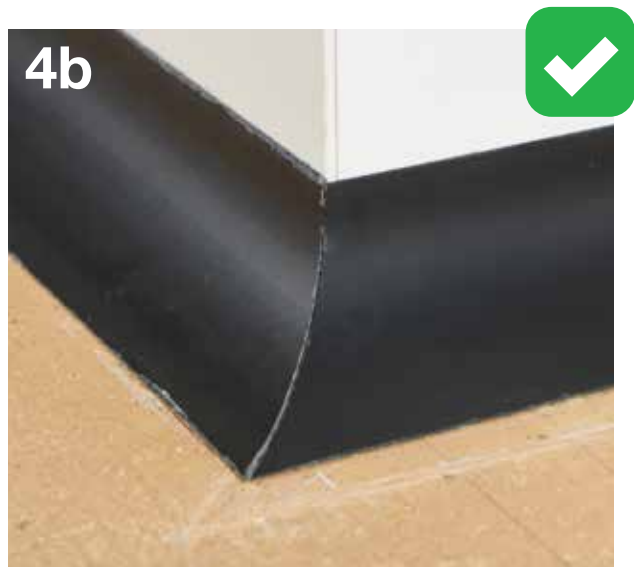
This shows a neat mitre with the cove former cut and fitted at the correct angle.

Neatly cut and fitted with no gaps, the flooring is supported.

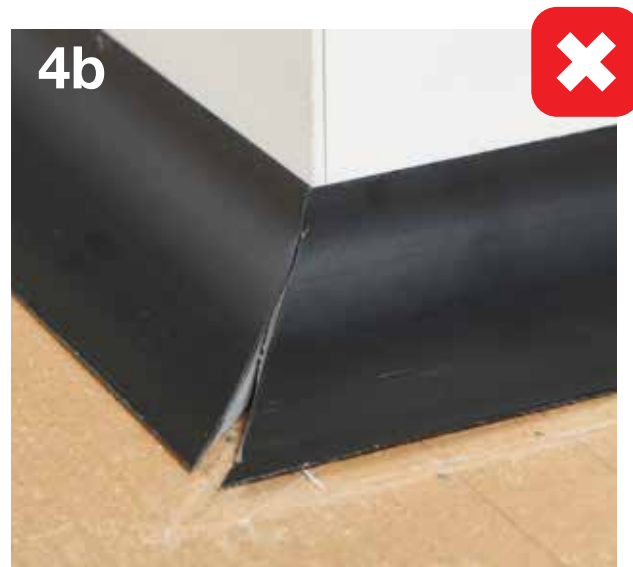
This shows a poorly cut and fitted cove former.

The gaps that result from the poor fit do not support the flooring that will sit on it. The floor will be susceptible to corner damage from wheeled traffic.

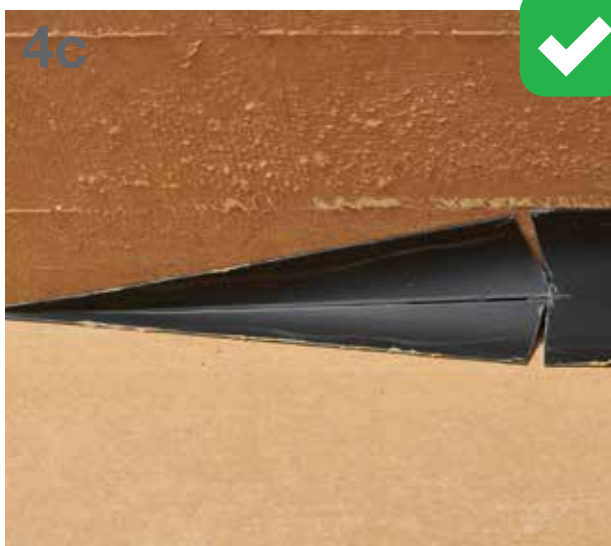
This shows a reduced cove former that will sit under the floor, next to the door frame.

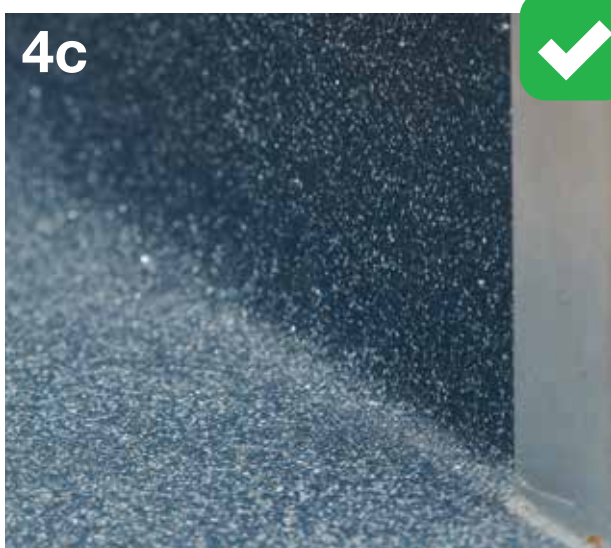
This shows the flooring installed over a reduced cove former, next to the door frame.

This ensures there are no gaps between the floor and the door frame. It looks good and no gaps mean no open areas for water ingress or bacteria.

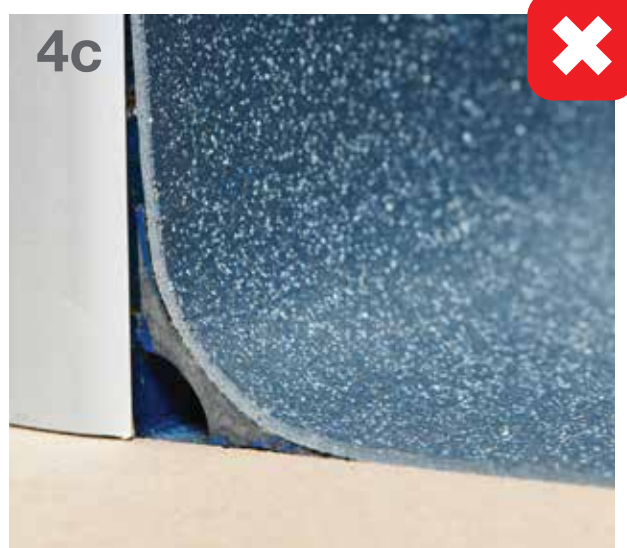
This shows the cove former leading up to the door frame, with no reduction. It sits proud of the frame.

Flooring that sits proud of a doorframe is prone to damage. The gap against the wall allows moisture and bacteria ingress.

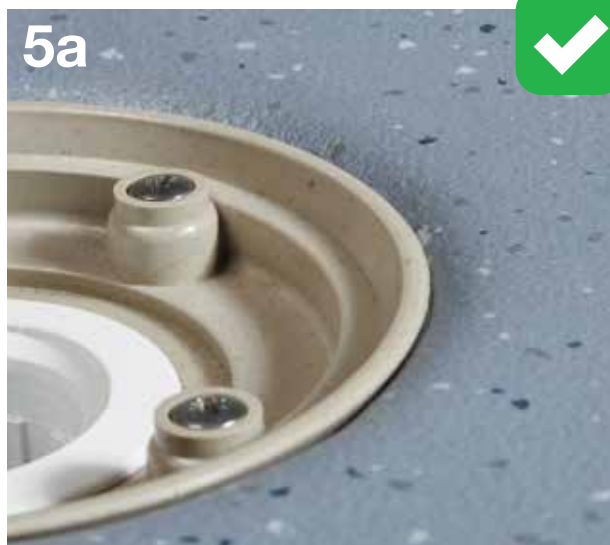
This shows the flooring folded in, with the drain fitted on top.

Folding the floor into a clamp drain ensures a tight, sealed fitting that prevents water and bacteria ingress.

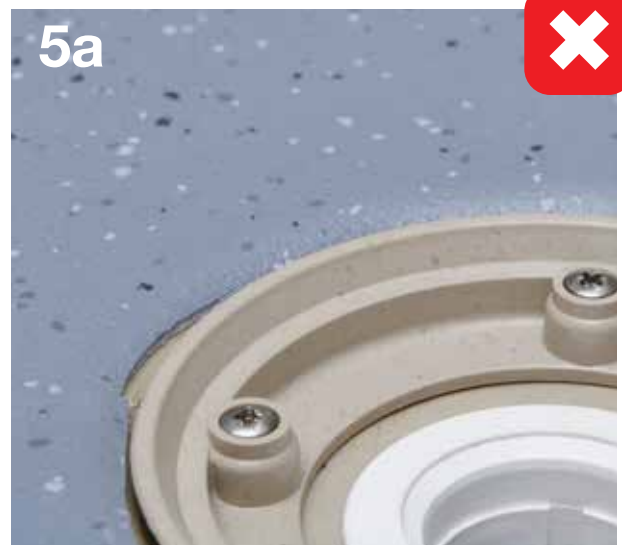
This shows the flooring cut around the top of the drain, leaving gaps.

The drain is not secured and the gap between floor and drain allows water, dirt and bacteria to get between the sub-floor and flooring. This is unhygienic and can cause the floor to lift.

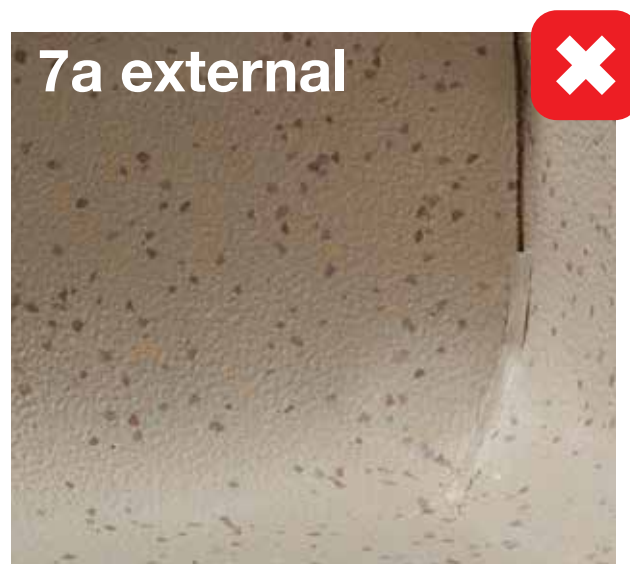
This shows an incomplete, poorly hot welded external corner, with gaps.

A poor weld leaves the corner prone to damage and the gaps allow water, bug and bacteria ingress. It is not aesthetically pleasing.

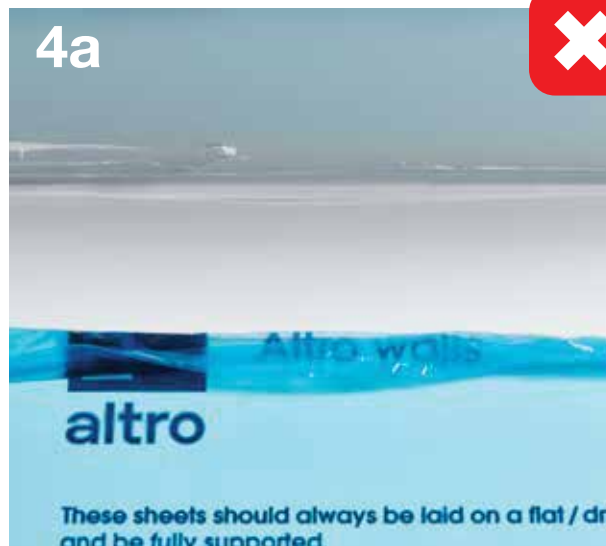
4a

This shows the large gap filled in with thick mastic.

Thick mastic could indicate the cover up of a massive gap, potentially not cut properly, or because the room was not planned properly. It is also likely to fail, which could allow ingress of dirt, bacteria and bugs. Aesthetically, it doesn't look good.

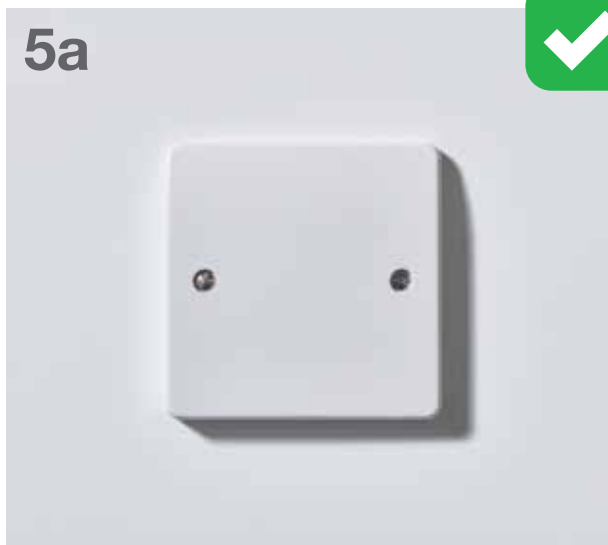
This shows the fitting overlapping the Altro Whiterock sheet.

The fitting overlapping the wall sheet is neat, tidy and aesthetically pleasing and is ideal for a non-hygienic environment.

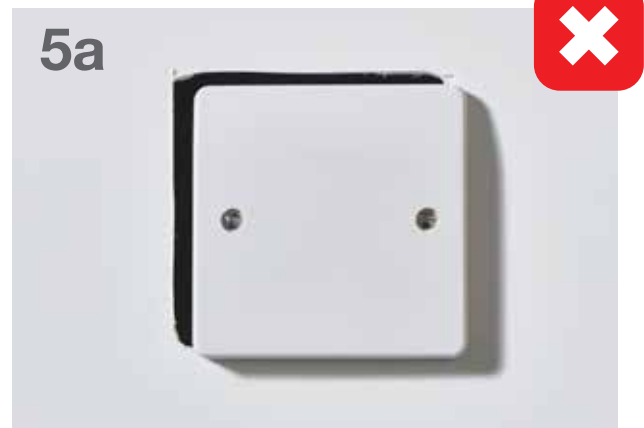
This shows a deep gap between the fitting and wall sheet.

A thick mastic, a wide gap or using additional wall sheet around a fitting shows poor planning and doesn't look good.

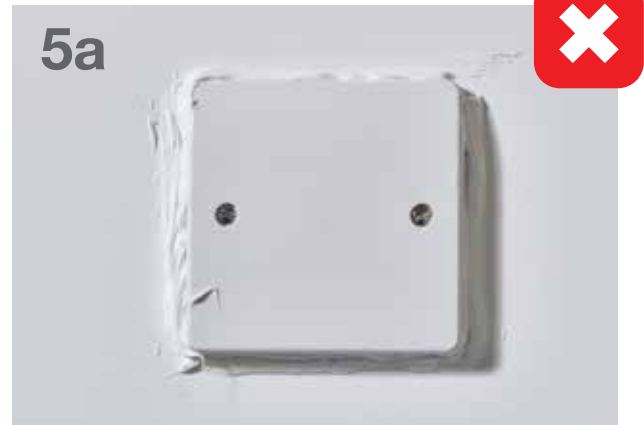
This shows the large gap filled in with thick mastic.

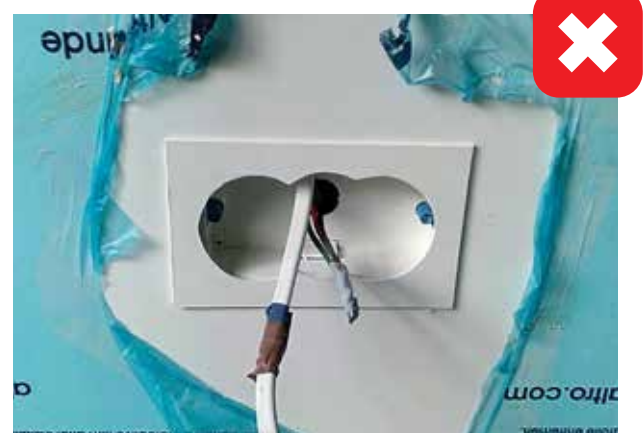
This shows a 'make-do and mend' approach. The sheet has been cut too short for the plug socket, so another piece of Altro Whiterock has been used to overlap the gap.

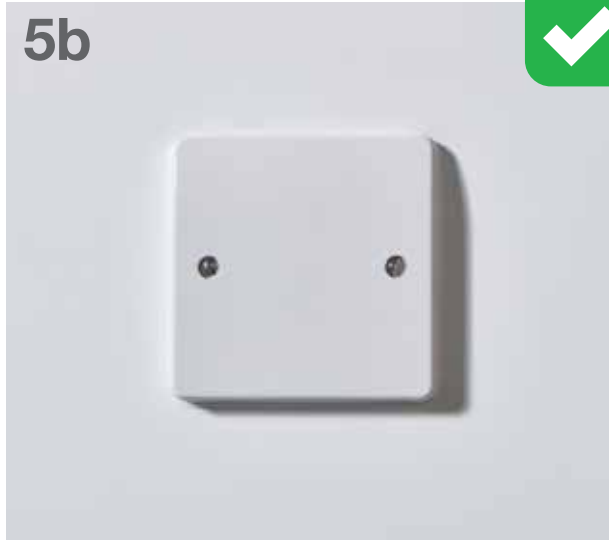
5b

The fitting overlaps the wall sheet and is finished with a thin 3mm bead of mastic.

The fitting overlapping the wall sheet is neat, tidy and aesthetically pleasing, with a thin mastic seal (approximately 3mm) around the edge to prevent bacteria and bug ingress.

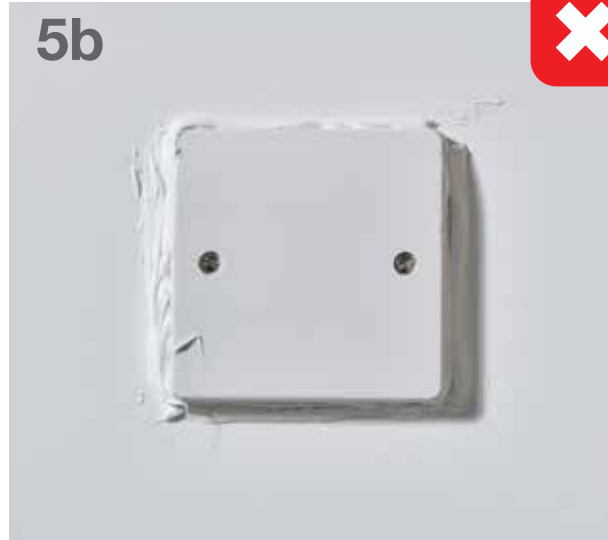
5b

The sheet has been cut too short for the plug socket and thick mastic has been used to fill the gap.

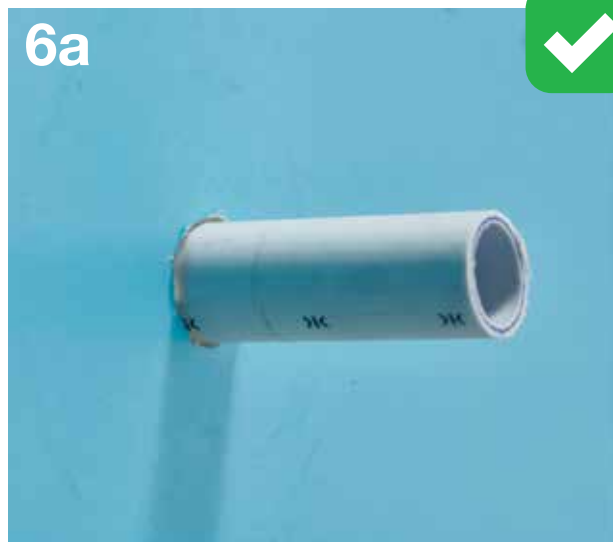
This shows a neatly cut, even sheet, with the recommended 3mm gap.

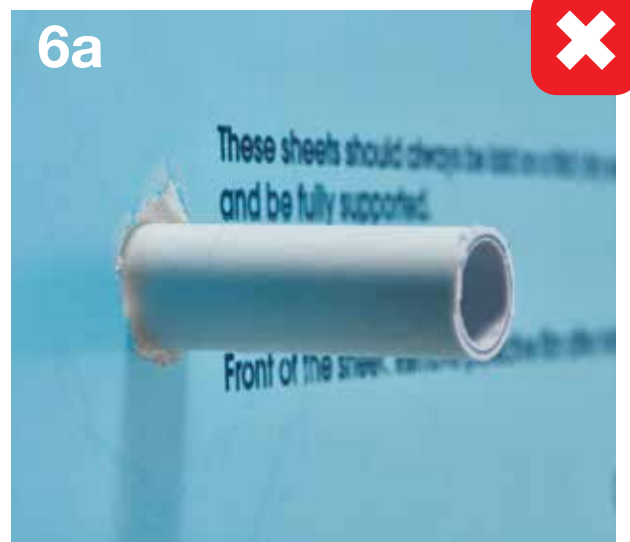
This shows the sheet, with a bad uneven cut. In parts it is wider than the recommended 3mm gap.

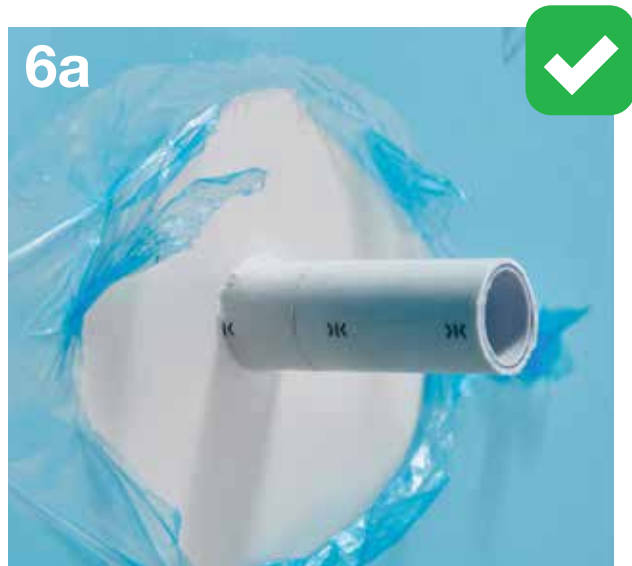
This shows pipework coming out of the wall sheet, sealed with neat mastic all the way round.

A thin, tight gap around the pipework looks good. A thin bead of mastic should be applied around any pipework or protrusions to create a neat and tidy seal (the mastic allows for movement).

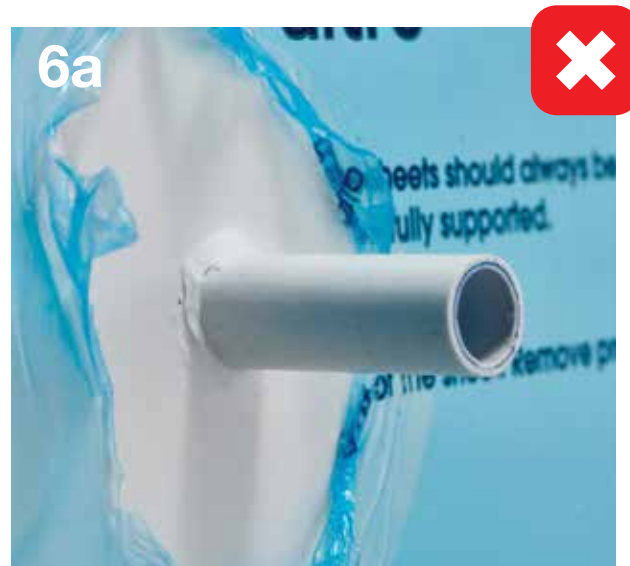
This shows an uneven, thick mastic seal with a gap on one side.

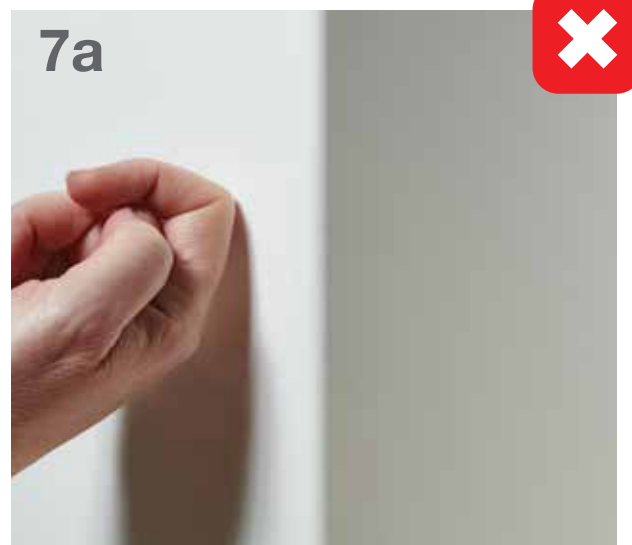
This shows someone testing the wall to check that it's fully bonded.

If the wall sheet is not fully bonded, bacteria could grow in the gaps, and the system is more vulnerable to damage.

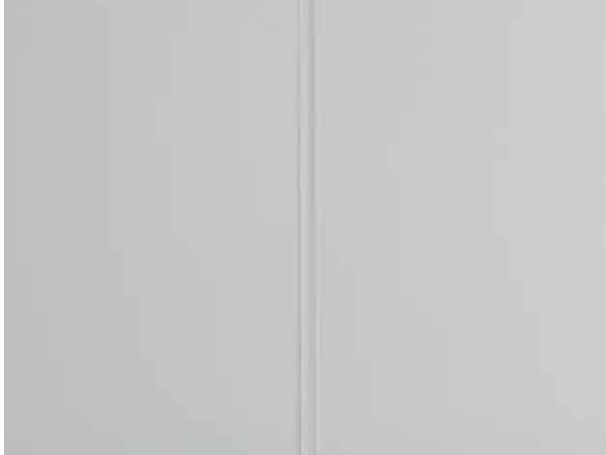
9a

This shows a clean joint; it has a good weld with no scratches.

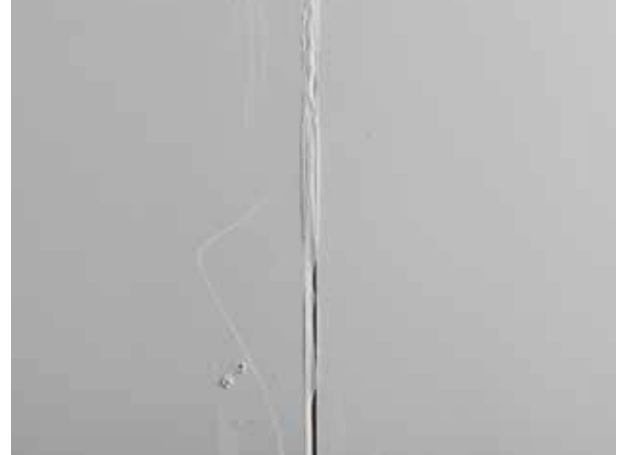
9a

This shows a poor weld, with gaps and scratches on the wall sheet caused by tools.

It's an example of poor installation. The weld will likely fail, allowing dirt, bacteria and bugs to ingress, and it's not aesthetically pleasing.

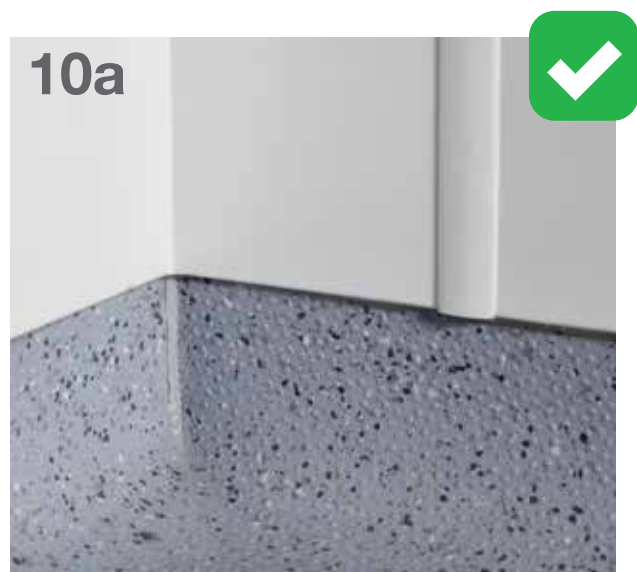
This shows an installation completed using a concealed transition strip. The wall overhangs the floor and is sealed with mastic.

Using a concealed transition means that the flooring doesn't need to be installed first. It makes the wall cladding 'kick-out' at the bottom so the flooring can go underneath and sit behind it. This means the wall sheet isn't adhered to the flooring behind, so it's easy to replace the flooring if needed. This type of transition means that any water runs down the wall and onto the flooring rather than hitting the joint. After this, the transition is silicone-sealed to avoid water bouncing back up from the floor and getting into the joint detail, creating a watertight finish.

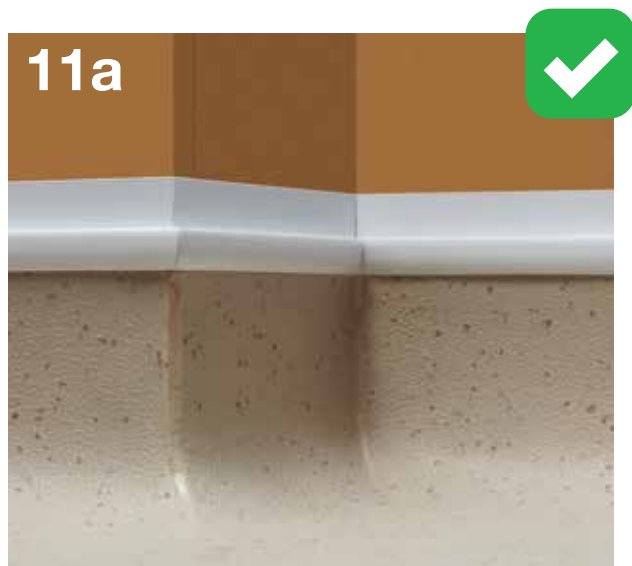
This shows neatly mitred internal and external captile corners.

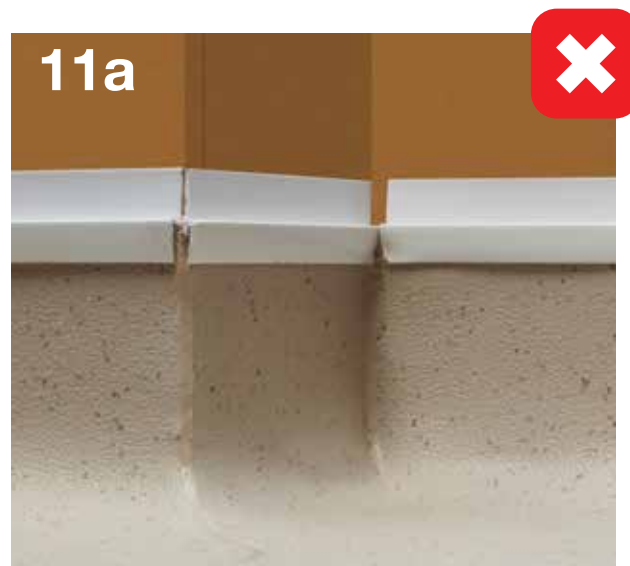
This shows poorly jointed internal and external captile corners, with visible gaps.

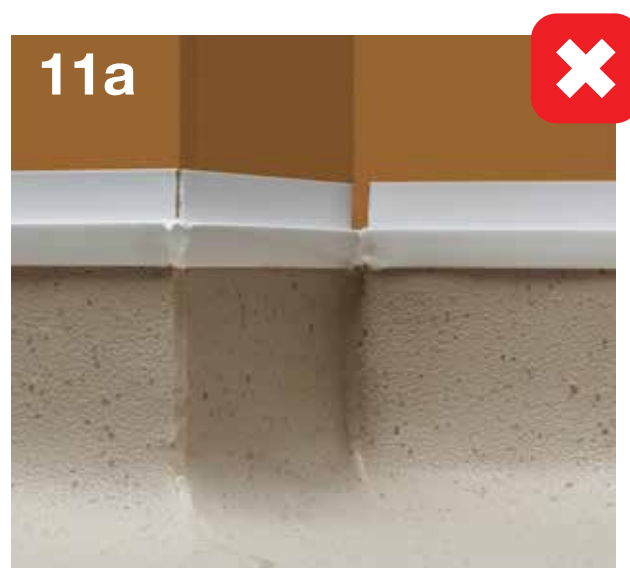
This shows poorly jointed internal and external captile corners, filled with thick mastic.

In a wet environment, water will run down the wall tiles and can find its way behind the captile strip, mastic and flooring. This could cause a system failure and is not aesthetically pleasing.

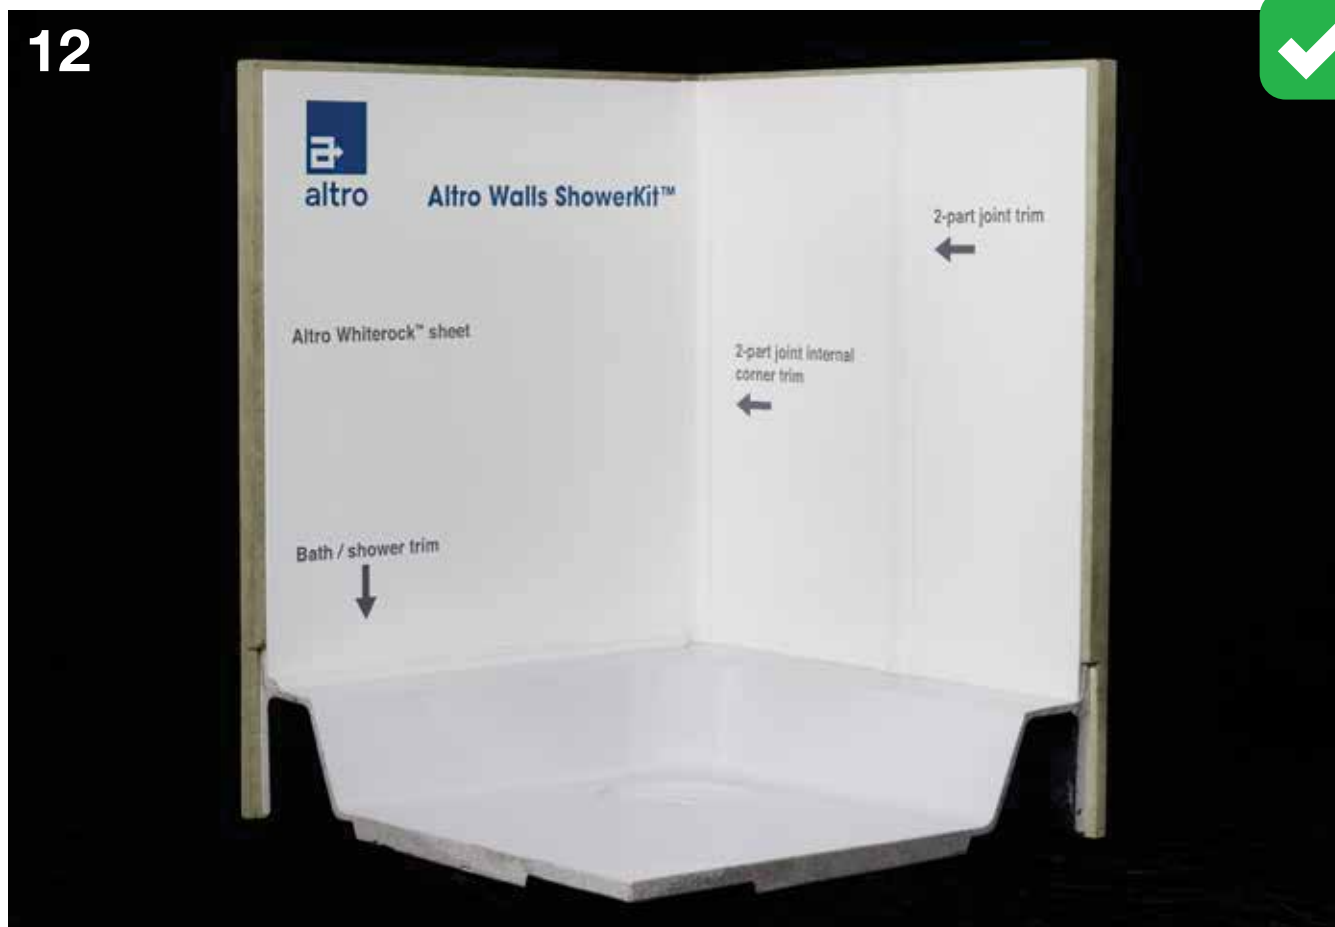
**Left-hand side:** this shows that the bath/shower trim is fitted tightly to the shower/bath top. The joints are finished with mastic to prevent water ingress.

A correctly-fitted, neat, thin mastic-sealed edge will prevent water ingress, be easier to clean and will prevent system failure.

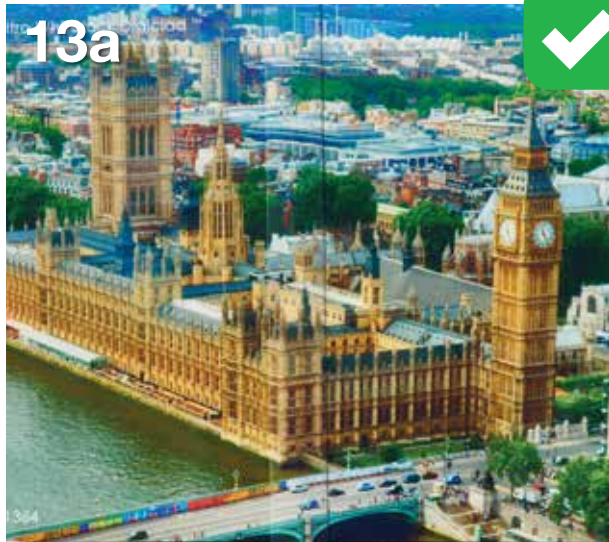
This shows two Altro Whiterock Digiclad sheets correctly lined-up, with a matching trim in place.

Aligned and aesthetically pleasing.

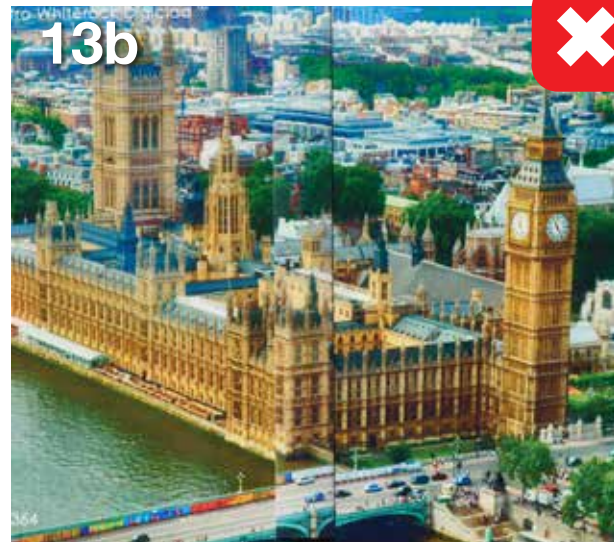
This shows two Altro Whiterock Digiclad sheets installed with a poorly aligned matching trim (take a close look at the bridge!).
